# Manhole Inspection Summary

Manhole # S21WW1020MH

**Location** Address: **5106 CROSS KEYS RD** Cross Street: **HAMLET HILL RD**

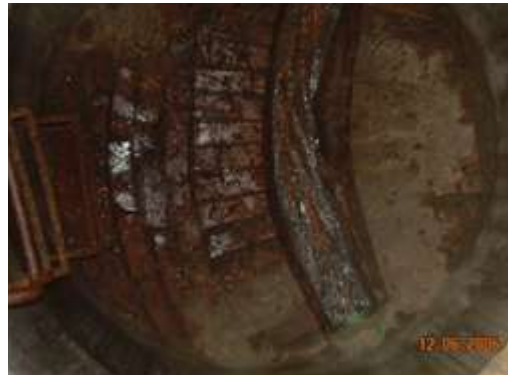
Top View

Corroded steps. Bench debris.

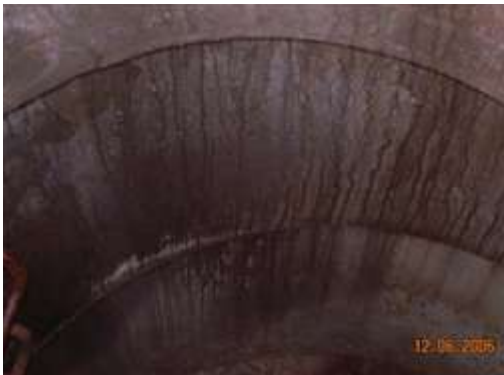
Defect

**Chimney / Frame Adjustment** ☒ Exists Material: **Brick** ☐ Parged Height: **12** (in.)  
Condition: ☒ Sound ☐ Cracked ☐ Root Intrusion ☐ Loose Brick ☐ Deteriorated  
Infiltration: ☐ None ☒ **Joint** ☐ Cracks ☐ Mortar ☐ Roots ☒ **Wall**

**Corbel** Material: **Precast Concrete** ☐ Parged Type: **Concentric/Eccentric**  
Condition: ☒ Sound ☐ Cracked ☐ Root Intrusion ☐ Loose Brick ☐ Deteriorated  
Infiltration: ☐ None ☒ **Joint** ☐ Cracks ☐ Mortar ☐ Roots ☐ Wall

Adjustment and Corbel infiltration.

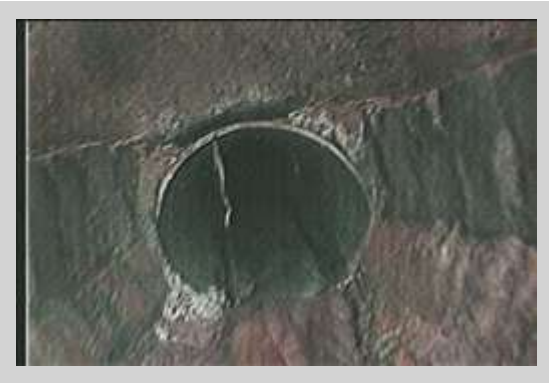
### 8 in. Circular Gravity Sewer Pipe Out @ 12 O'Clock

Comments **The O12 pipe seal is not flush to the pipe.**

Infiltration: **Evidence** Pipe Seal Cond: **Roots**

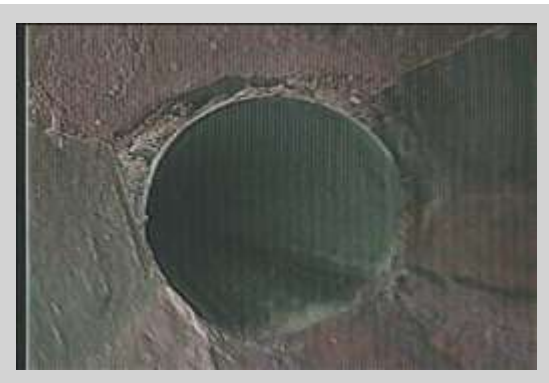
### 8 in. Circular Gravity Sewer Pipe In @ 5 O'Clock

Deposits: ☐ None ☒ **Mud** ☐ Sludge ☐ Debris ☒ **Grease**

Silt Depth: **0** (in.) Deposits Extent: **Light**

Infiltration: **Evidence** Pipe Seal Cond: **Broken**
